**Results of Blue Sink Pumping Test No. 2  
Hillsborough County, Florida**

**Hydrologic Evaluation Section  
Southwest Florida Water Management District**

**September 2009**

**By Jason Patterson and Ron Basso, P.G.**

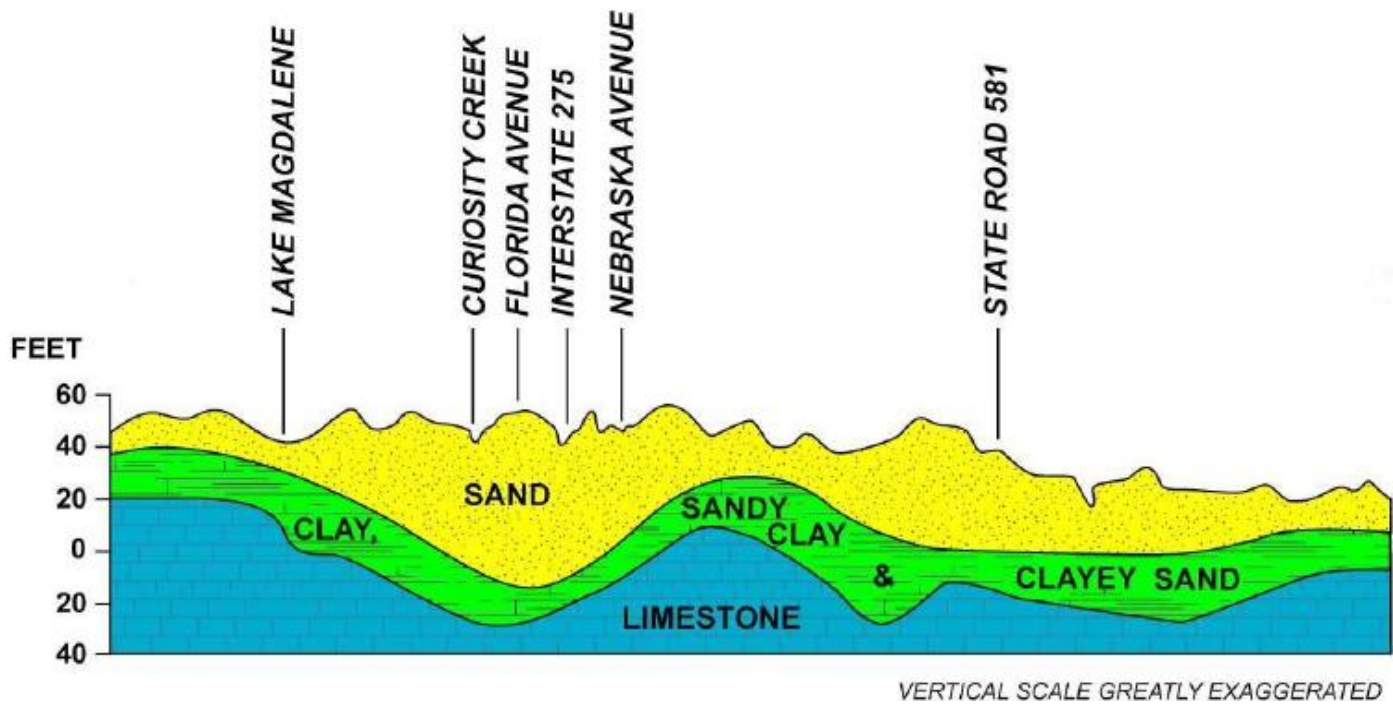
Figure 3. West to east hydrogeologic cross-section near the Blue Sink area.

The Blue Sink complex of sink features is located within the Sulphur Springs contributing area. Sulphur Springs is located about 2.3 miles south of Blue Sink and discharges an average of 44 cfs to the lower Hillsborough River. According to well installation logs in the area, the lithology within the vicinity of Blue Sink consists of fine sand to approximately 20 ft below land surface (bls), clay from approximately 20 to 25 ft bls and limestone below approximately 25 ft bls. A hydrogeologic cross section of the Blue Sink area is presented in Figure 3.

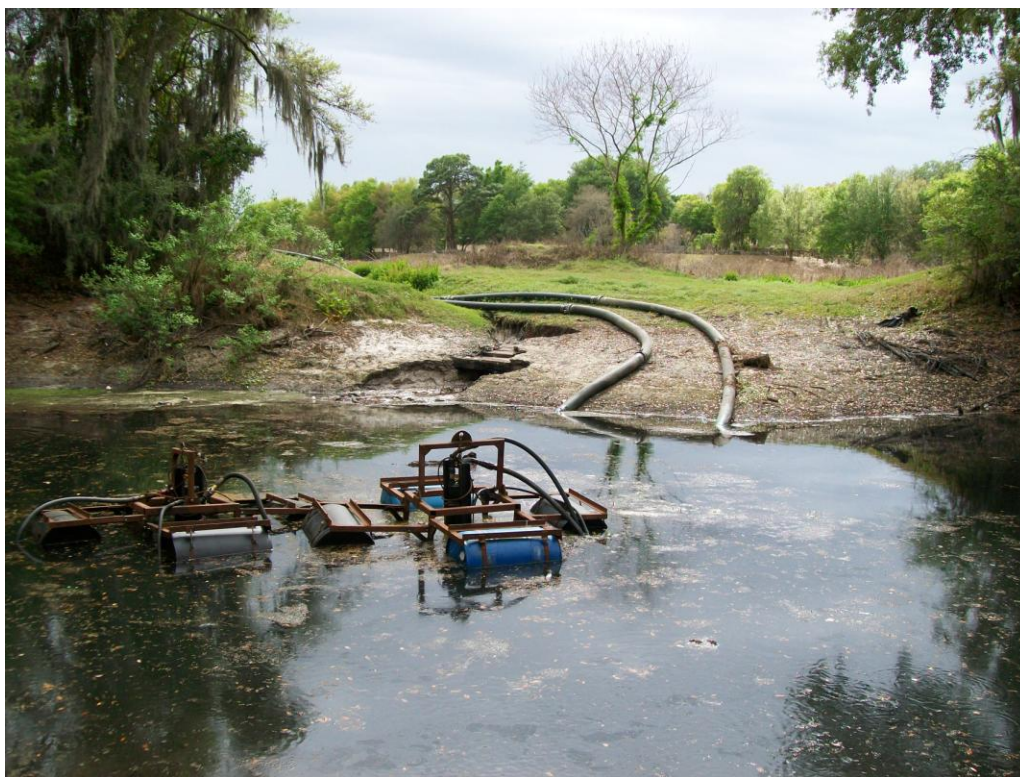
Figure 4. Pumps and discharge lines used in the Blue Sink test.

The pumping test was initiated at 9 a.m. on March 2, 2009 and ended at 9 a.m. on April 1, 2009. Prior to the pumping test, two pumps were installed in Blue Sink (Figure 4). Each pump was capable of discharging approximately two (2) mgd for the 30-day period. The intake features for each pump were mounted on barrel floats in the sink.

Two pumps were set-up so that continuous pumping could occur during the test while one motor was shut down for maintenance. Only one pump discharged water at any given time. The water discharged from the sink was directed via a pipeline into the City of Tampa's storm water pond (F100-C), located approximately 1,200 ft south of Blue Sink (Figure 2). At the end of the discharge pipe, flow data was collected by an in-line flow meter and two (2) manometers at 15-minute intervals. Thick plastic matting was also installed where the water discharged into the pond to prevent erosion.

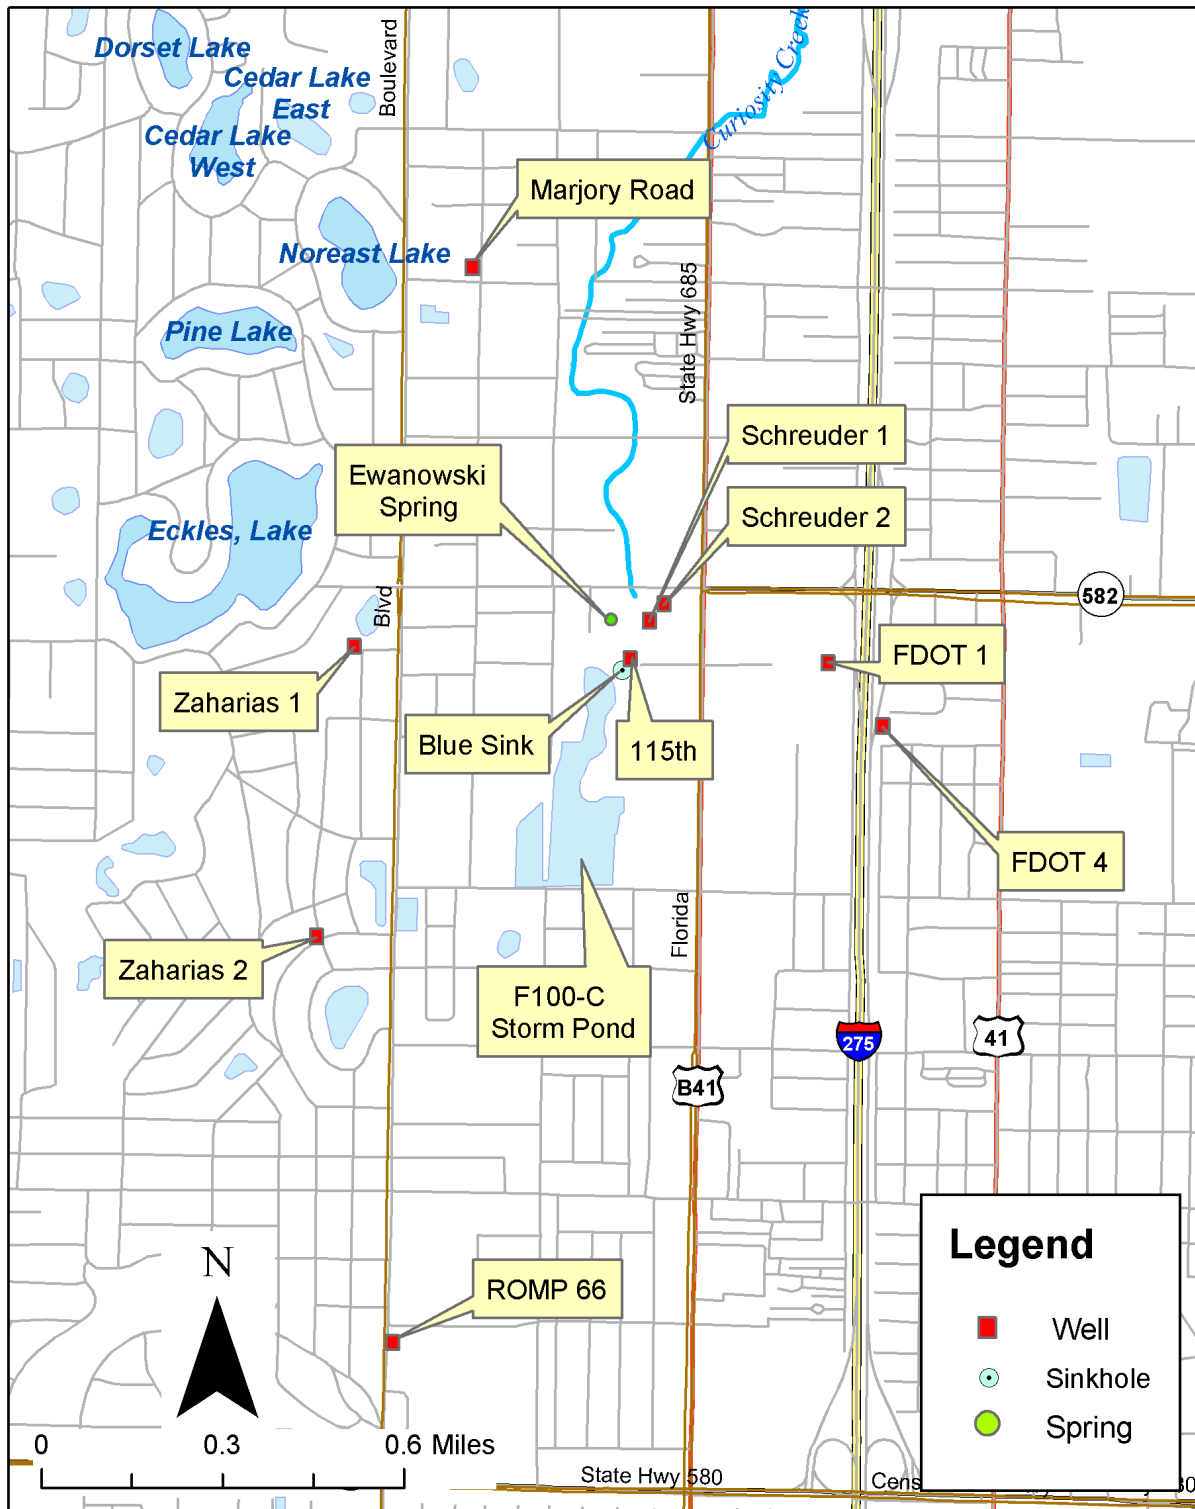
Figure 5. Location of Blue Sink, Ewanowski Spring, Upper Floridan aquifer wells, and lakes monitored during the pumping test.

Continuous water level data has been collected at Blue Sink, Ewanowski Spring, five (5) lakes and eight (8) UFA monitor wells since mid-to-late 2007 (Appendix A). During the pumping test, water level data was collected at all sites at 15-minute intervals. The location of all monitored sites is shown in Figure 5. The distance from Blue Sink for each monitoring site is shown in Table 1.

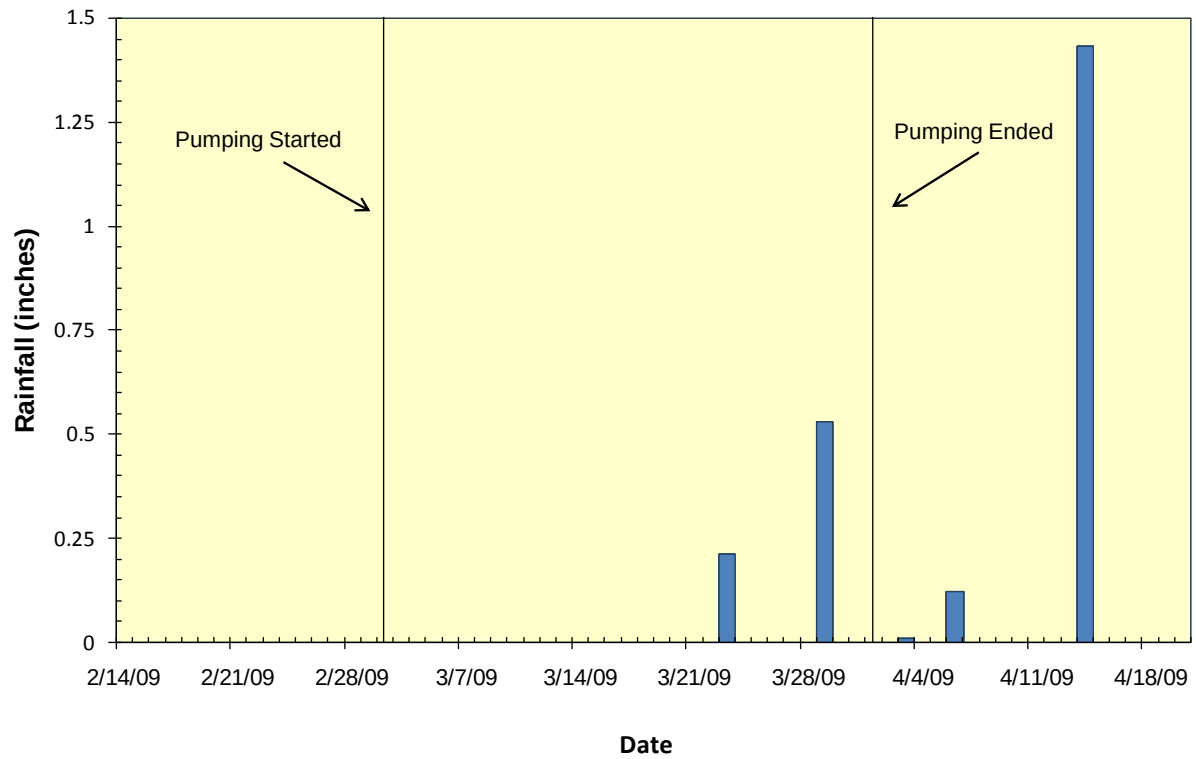
Figure 6. Rainfall recorded at the Marjory Road site from February 14 to April 20, 2009.

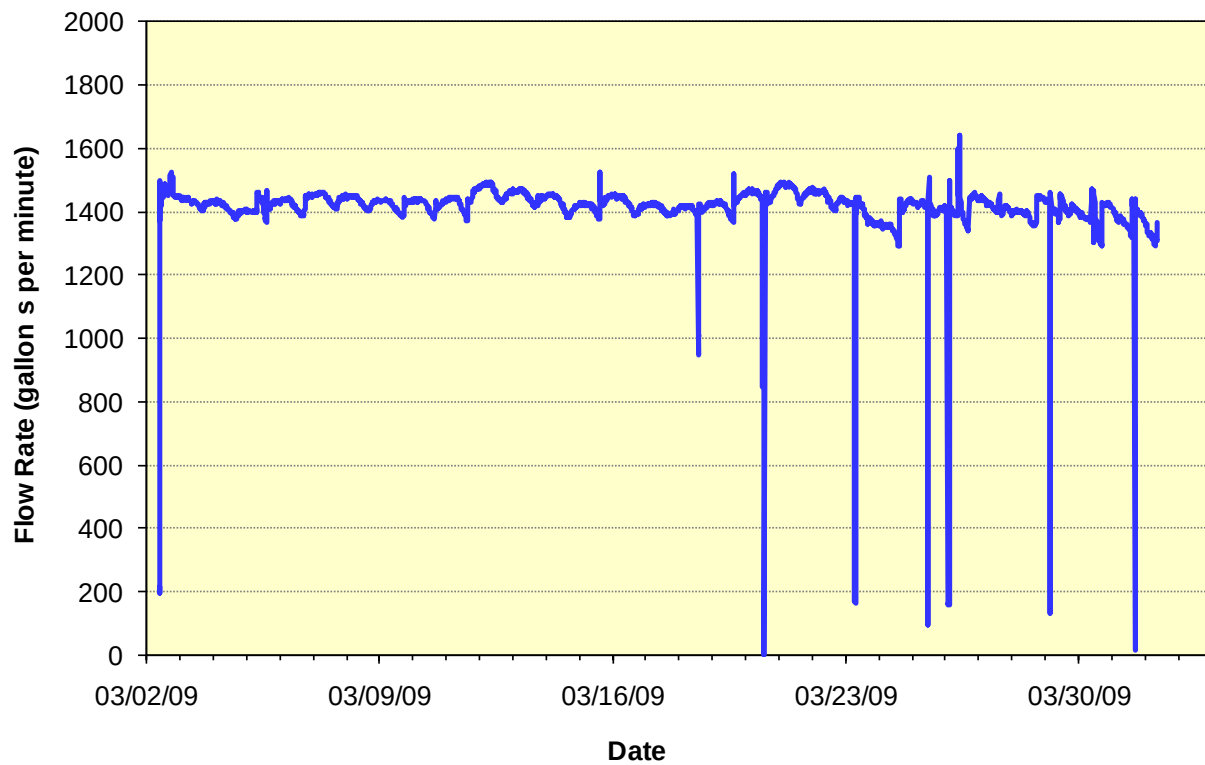
Figure 7. Discharge rate from Blue Sink (15-minute interval).

Flow was measured using a flow meter and two manometers at 15-minute intervals during the pumping test (Table 4 and Figure 7). Data from the flow meter was not available due to a mechanical failure caused by sediment and other debris. The measured flow rates from Manometer 1 were essentially the same as Manometer 2 readings. The average flow rate during the pump test was 1,412 gpm from Manometer 1 and 1,411 gpm from Manometer 2. The average from both manometers was 1,412 gpm or approximately two mgd. The largest 15-minute fluctuations between Manometer 1 and Manometer 2 ranged from -25 percent to 34 percent (Table 4). Total discharge from Blue Sink was approximately 61 million gallons during the 30-day test.

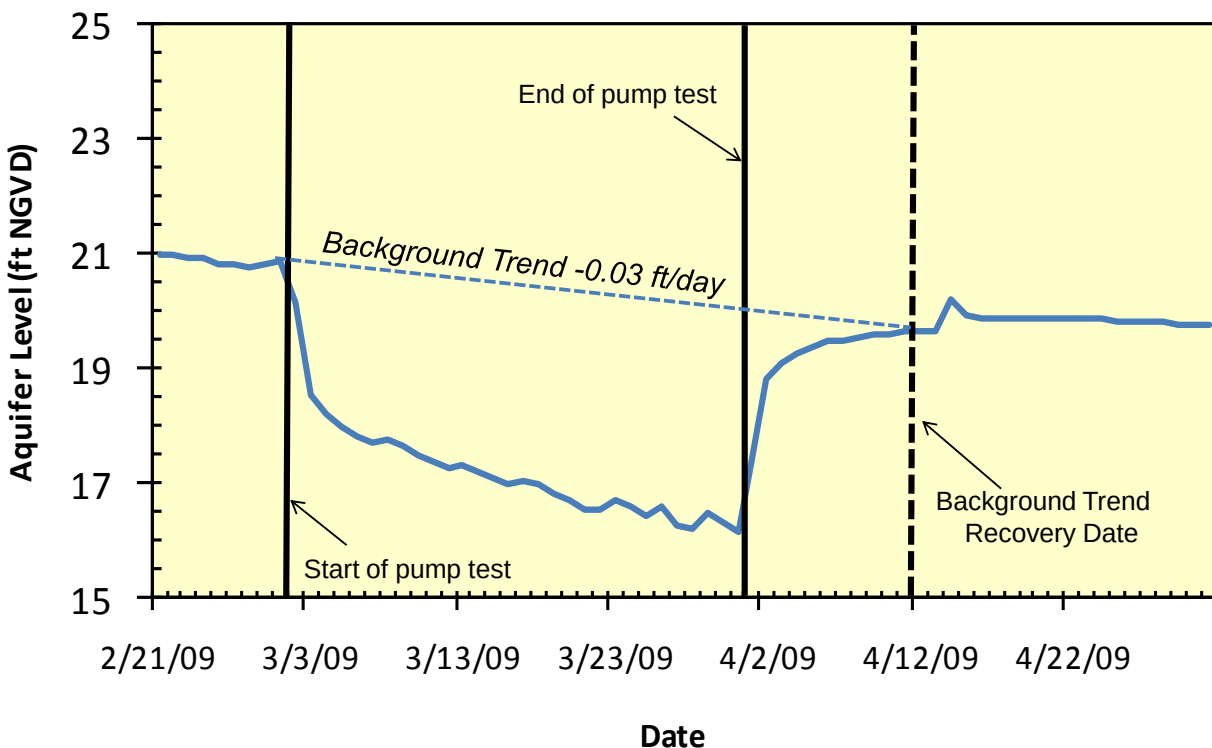
Figure 8. Hydrograph of Blue Sink stage with background trend.

The background water level trend for each monitor site was determined by the difference in water level just prior to the start of pumping on March 1 (8:45 am) and the water level on April 12<sup>th</sup> at 8:45 am or 11 days after pumping was discontinued at Blue Sink. The selection of April 12<sup>th</sup> was based on examination of Blue Sink stage recovery after pumping was terminated. Water level rise in the sink had slowed to just 0.01 feet per day after 11 days of recovery (Figure 8). On April 14<sup>th</sup>, a major rainfall event took place with 1.43 inches of rain recorded at the Marjory Road site.

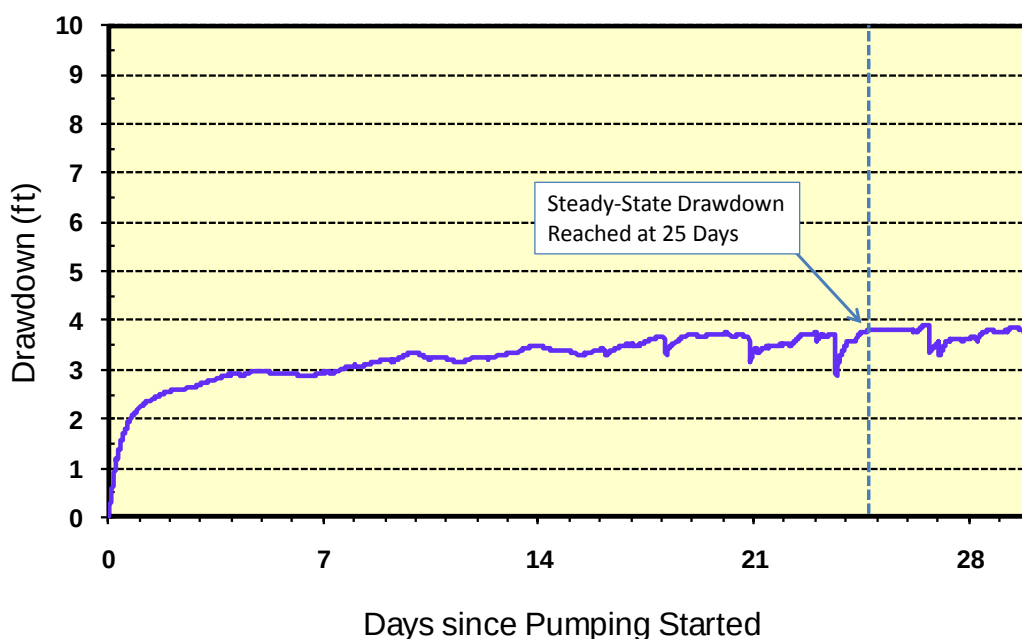
Figure 9 . Drawdown in Blue Sink stage during the duration of the 30-day test.

Blue Sink drawdown approached a quasi steady-state condition after about 25 days of withdrawals as it remained relatively steady around 3.7 ft (Figure 9). This condition was also reflected in Ewanowski Spring pool stage and UFA monitor wells surrounding the sink (Appendix C). The minor oscillations in drawdown depicted below after 25 days were mainly due to small alterations in the pumping rate.

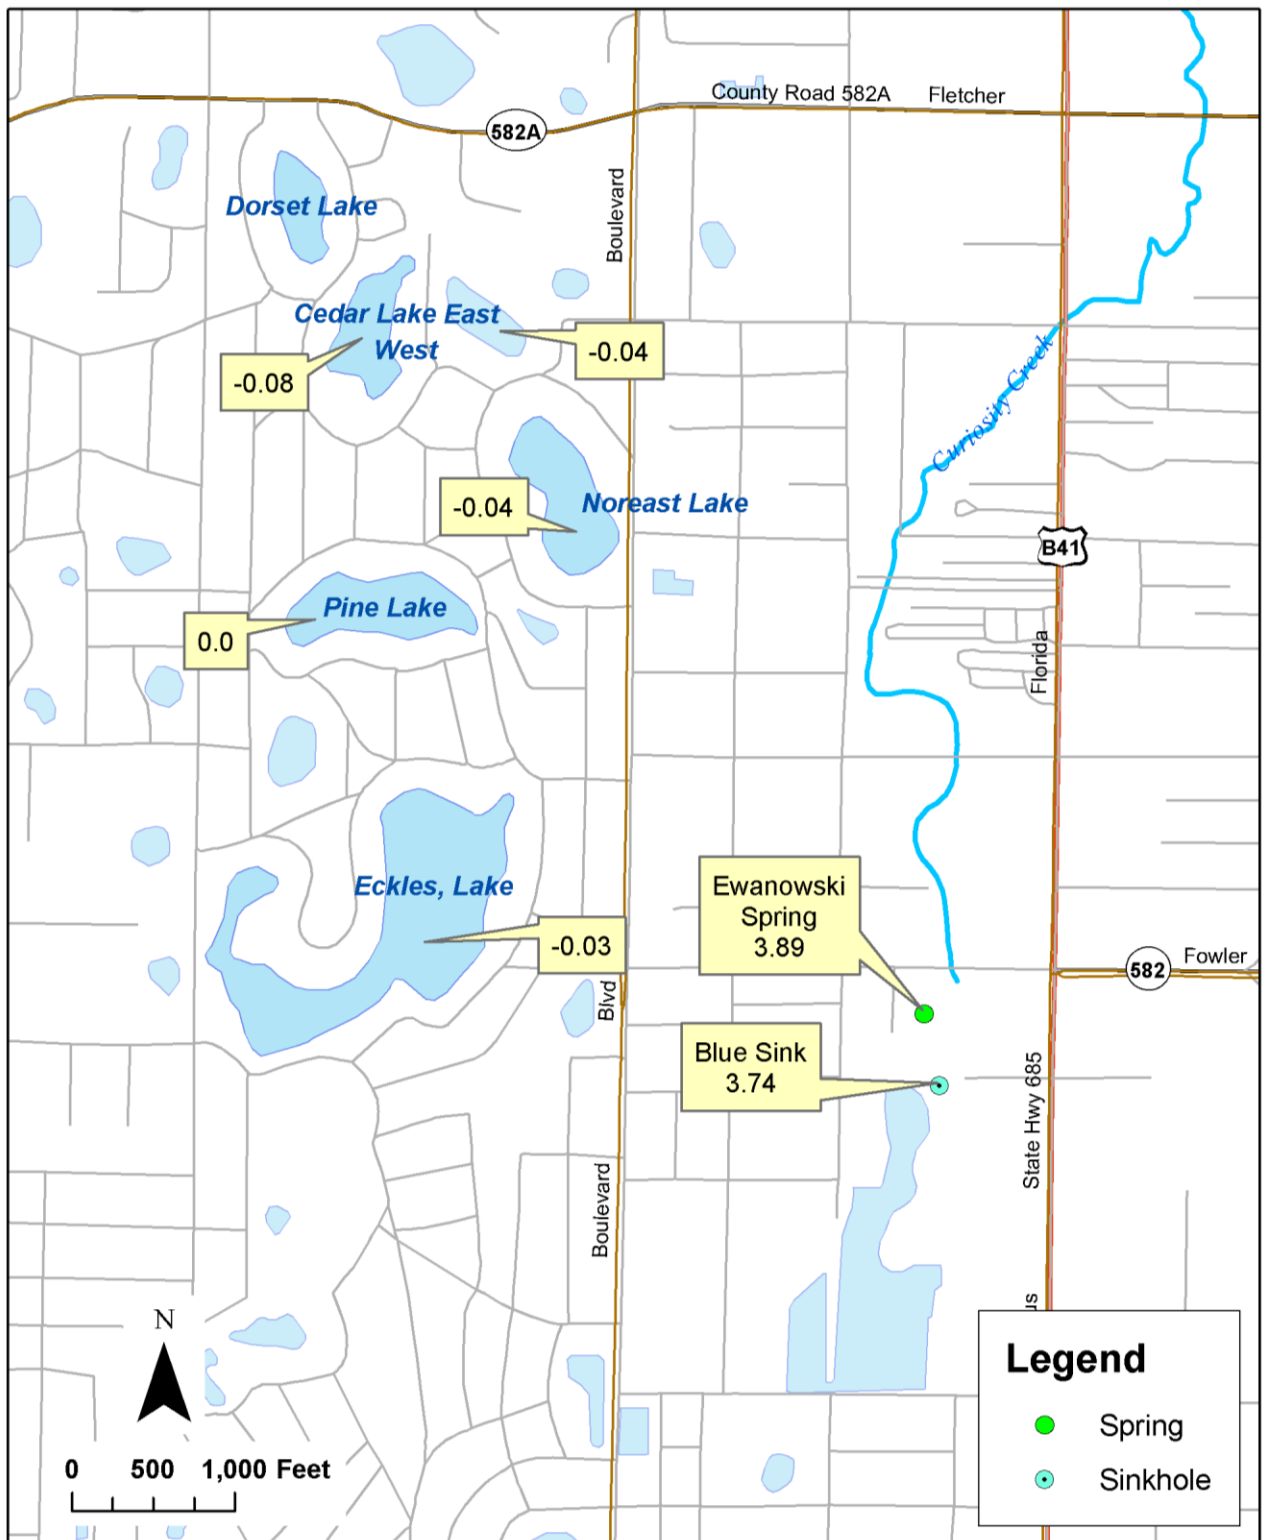
Figure 10. Lake drawdown calculated from the Blue Sink pumping test (note: negative values indicate increasing water levels at the end of 30 days of withdrawals).

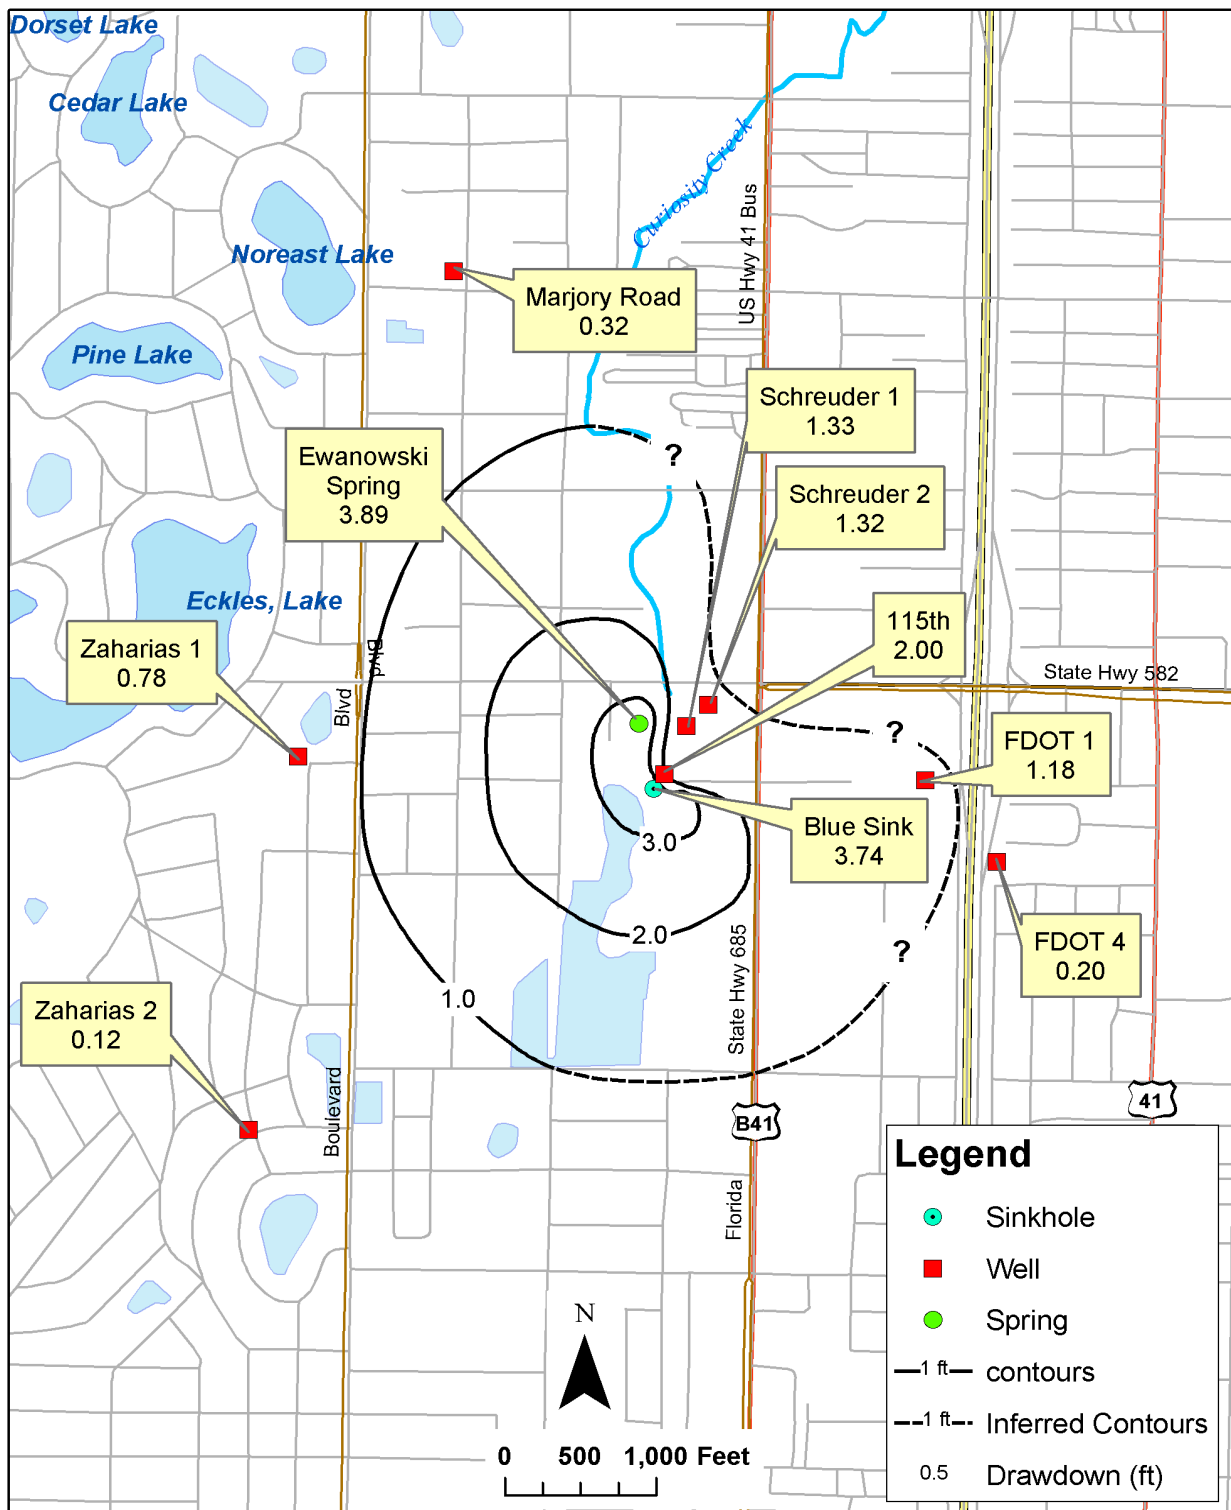
Figure 11. Drawdown in the Upper Floridan aquifer from the Blue Sink pumping test.

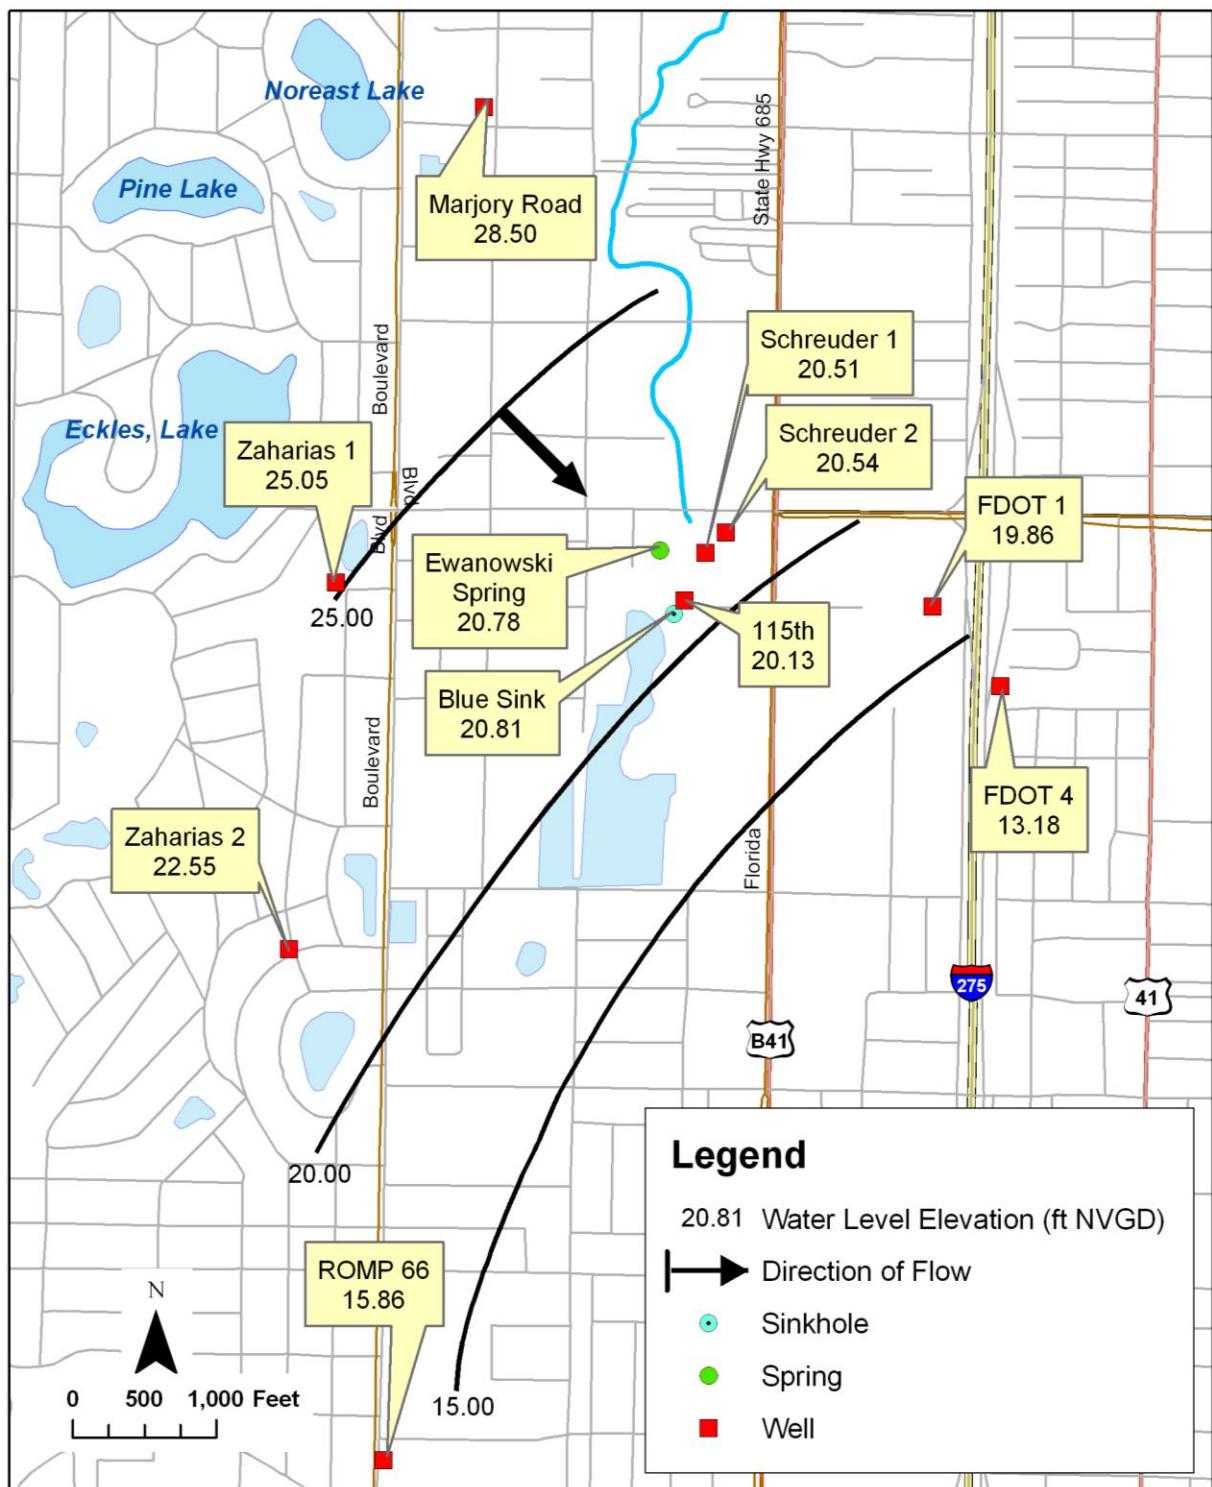
Figure 12. Groundwater flow direction and potentiometric surface of the Upper Floridan aquifer, February 25, 2009.

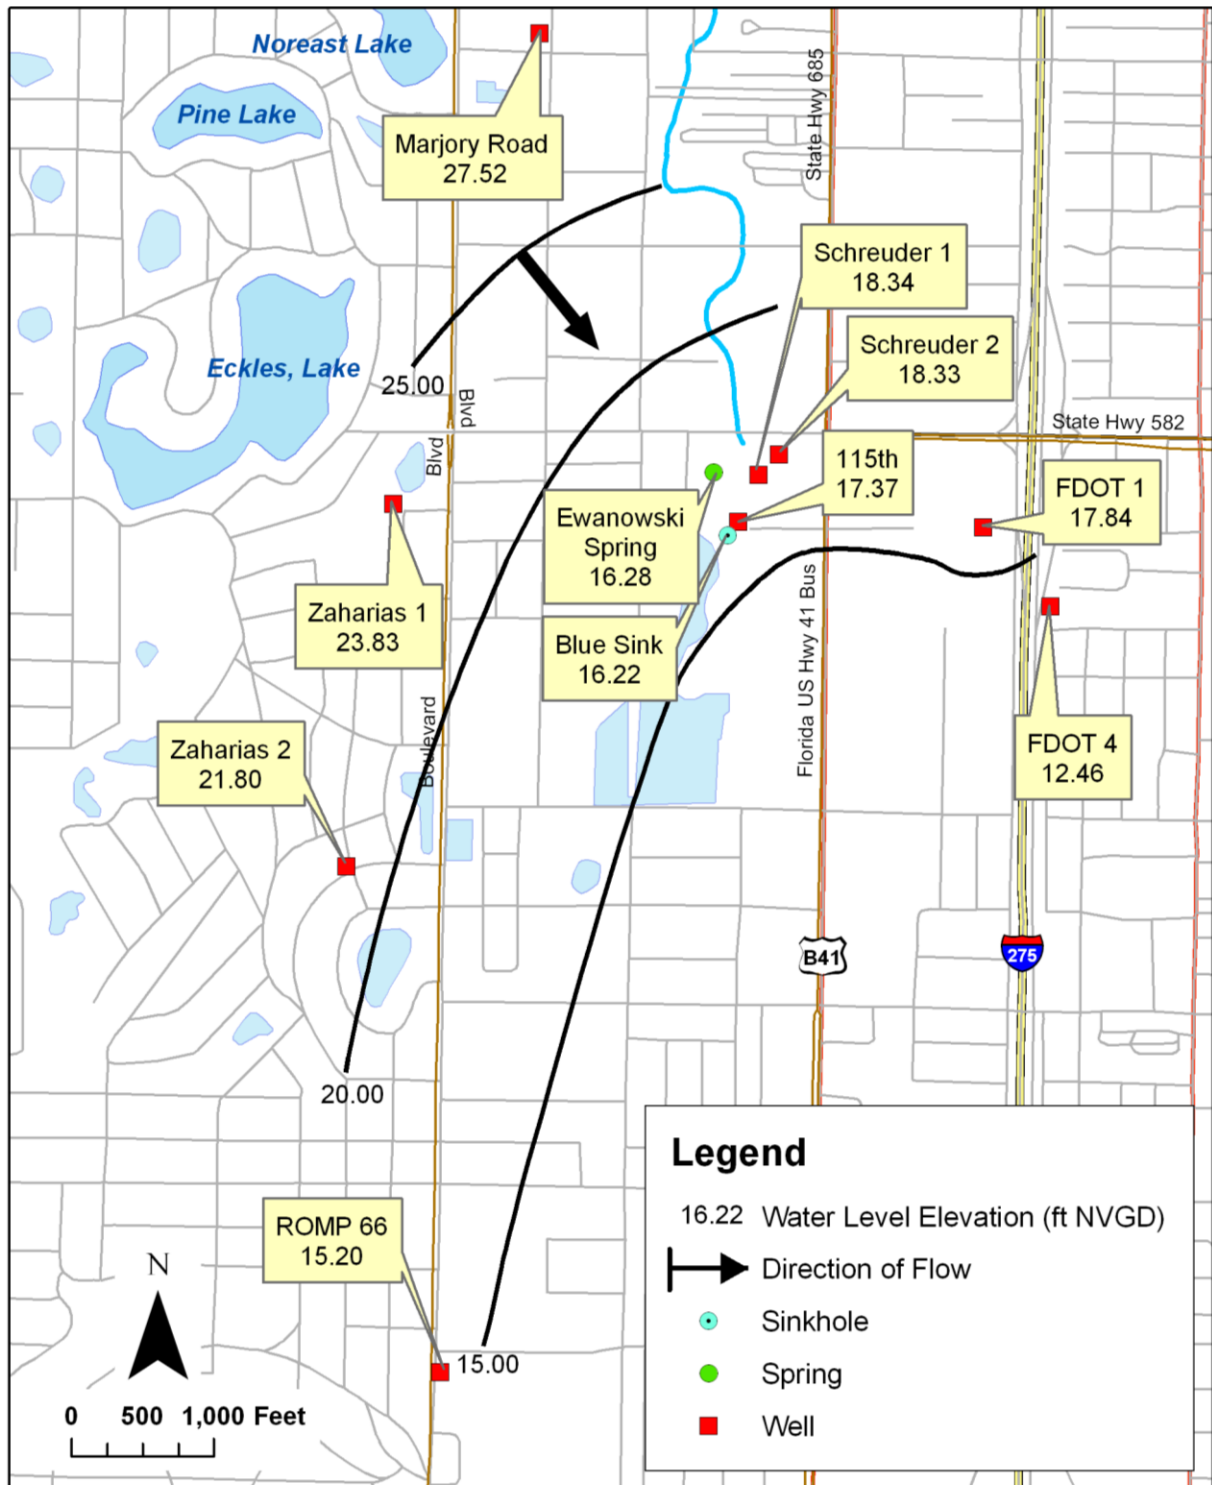
Figure 13. Groundwater flow direction and potentiometric surface of the Upper Floridan aquifer, March 28, 2009.

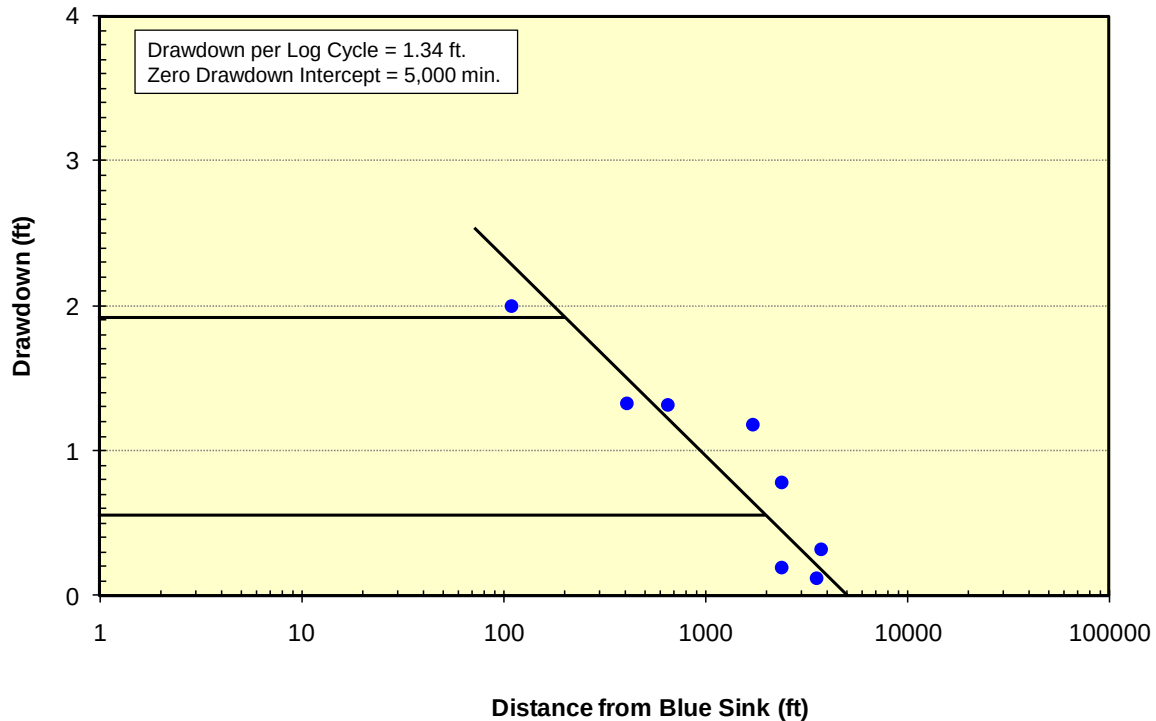
$$\text{Transmissivity} = 74,000 \text{ ft}^2/\text{d}$$

$$\text{Storage Coefficient} = 0.20$$

Figure 14. Distance-drawdown plot from the Blue Sink pumping test.

The transmissivity value of 74,000 ft<sup>2</sup>/d is slightly higher than the results of 63,000 ft<sup>2</sup>/d determined from a 24-hour aquifer test performed on an 80-foot temporary well installed near well FDOT-2 (Schreuder, 2001). Additionally, this transmissivity result is also slightly higher than 66,000 ft<sup>2</sup>/d from first Blue Sink test conducted by the District in May 2008.

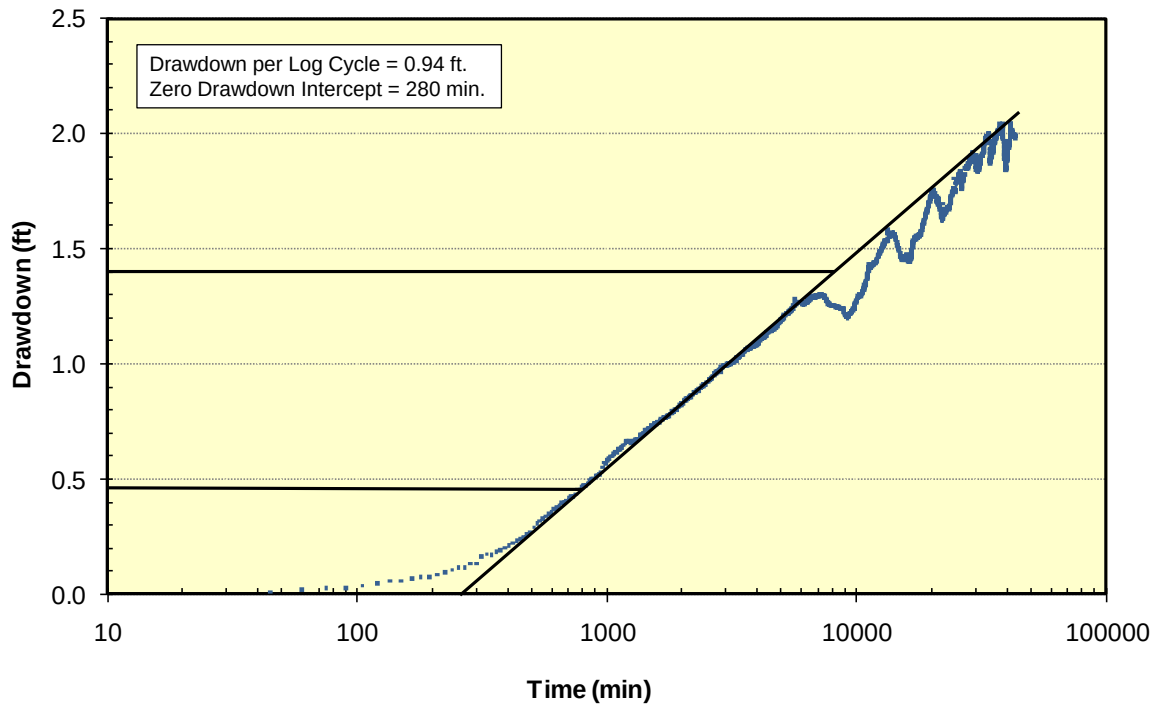
Figure 15. Drawdown versus time analysis using the Cooper-Jacob method for the 115<sup>th</sup> Avenue well.

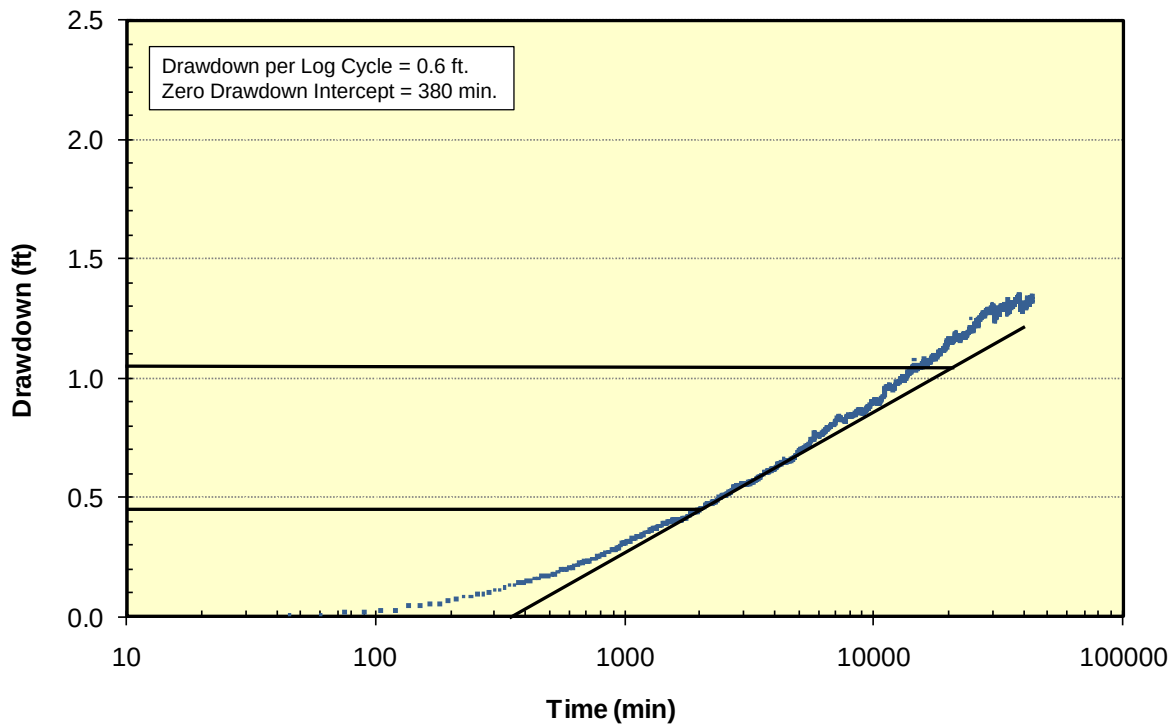
Figure 16. Drawdown versus time analysis using the Cooper-Jacob method for the Schreuder 1 well.

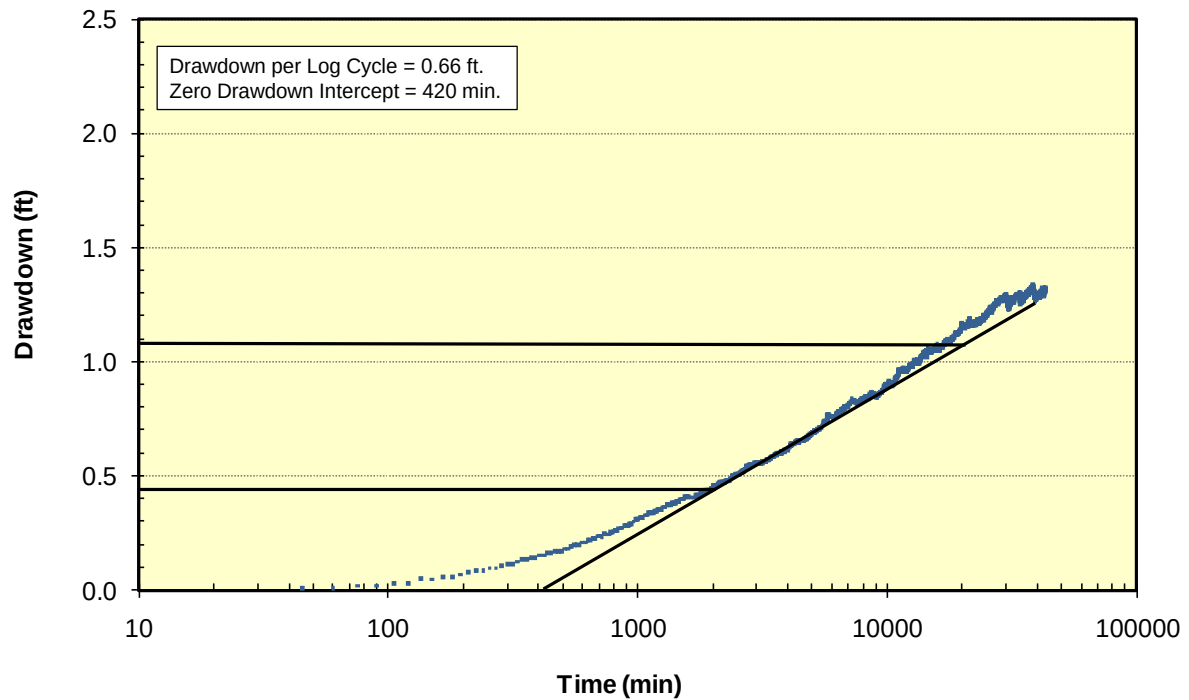
Figure 17. Drawdown versus time analysis using the Cooper-Jacob method for the Schreuder 2 well.

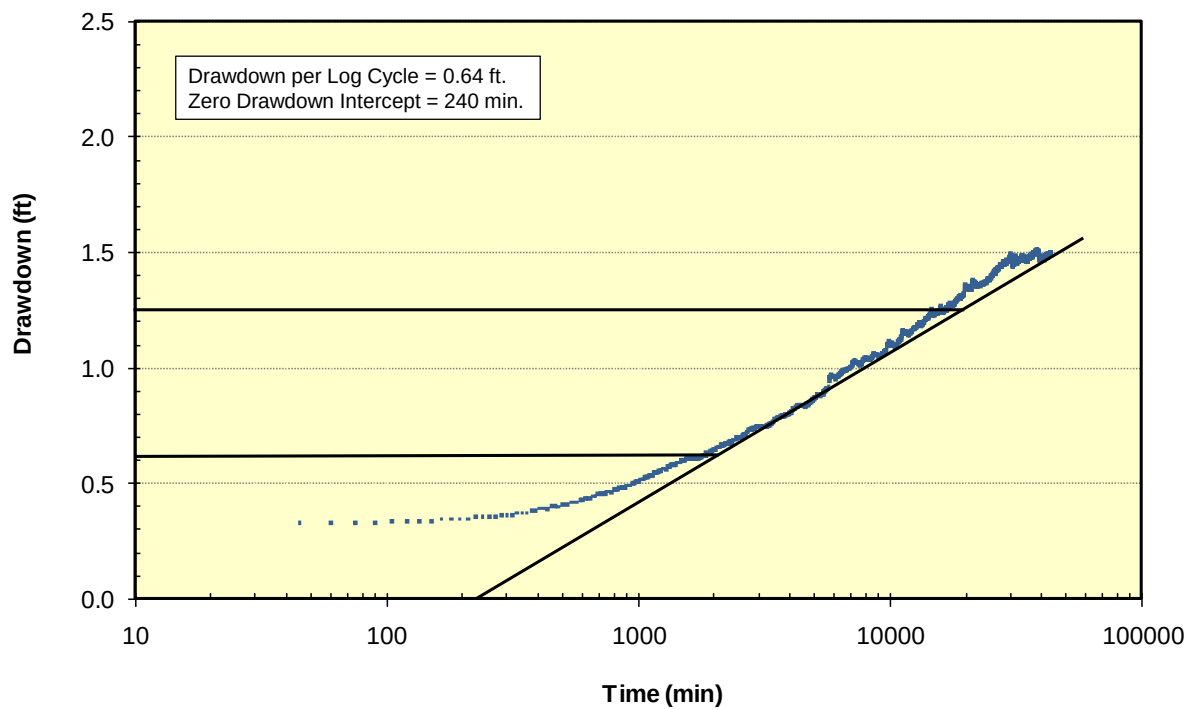
Figure 18. Drawdown versus time analysis using the Cooper-Jacob method for the FDOT 1 well.

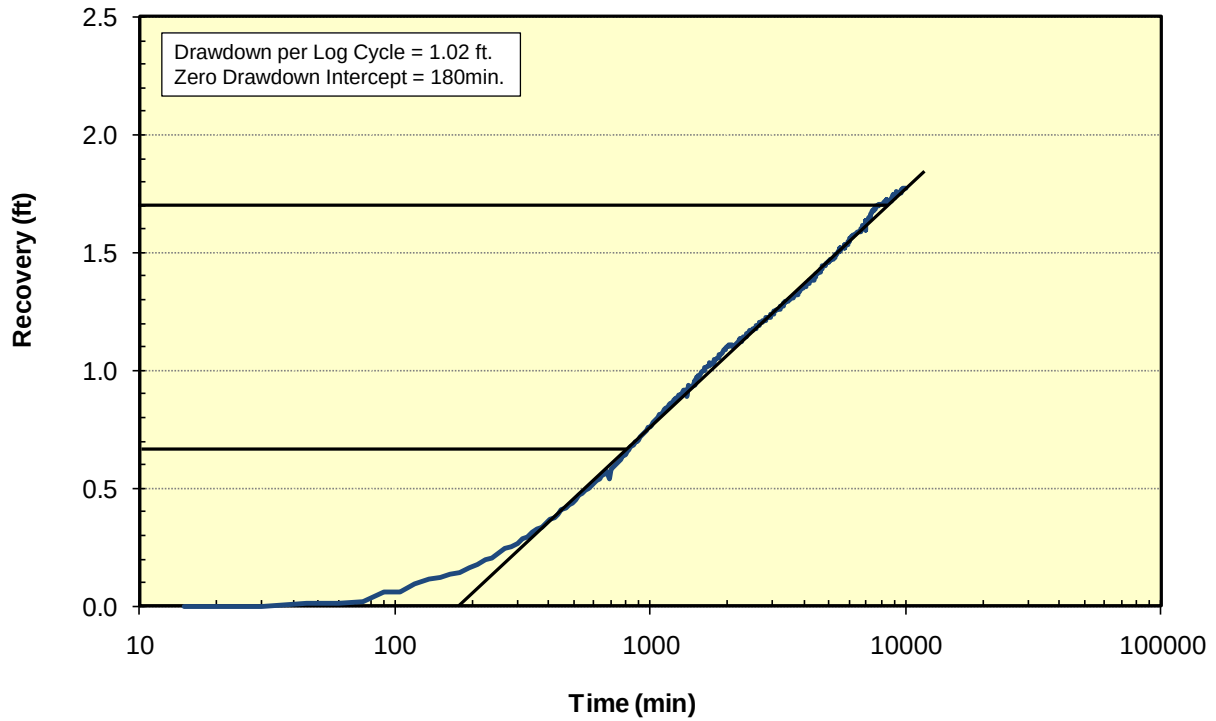
Figure 19. Recovery analysis using the Cooper-Jacob method for the 115<sup>th</sup> Avenue well.

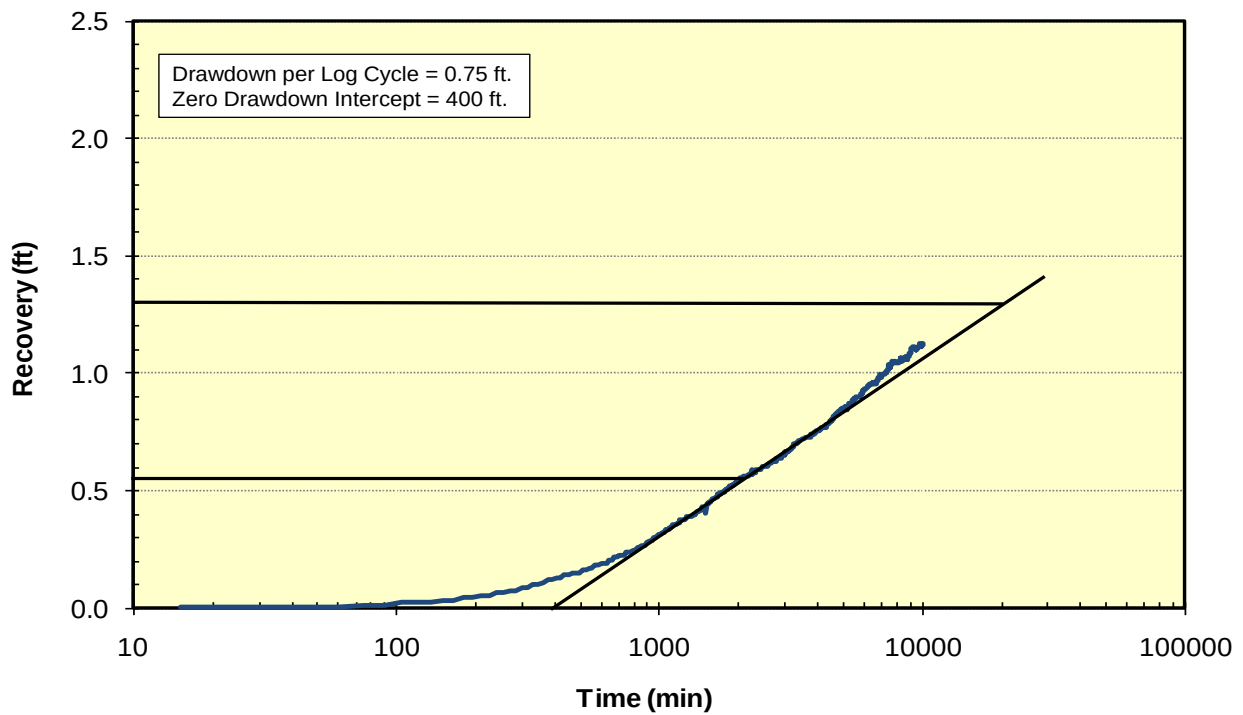
Figure 20. Recovery analysis using the Cooper-Jacob method for the Schreuder 1 well.

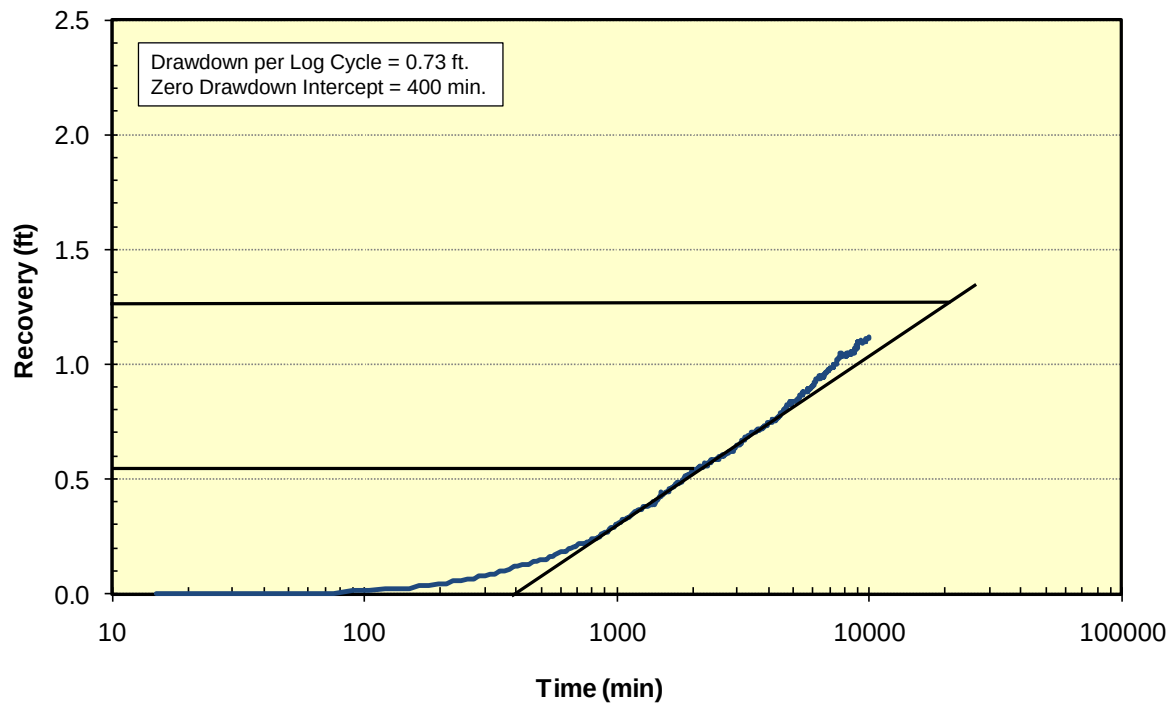
Figure 21. Recovery analysis using the Cooper-Jacob method for the Schreuder 2 well.
