**Results of Blue Sink Pumping Test No. 2  
Hillsborough County, Florida**

**Hydrologic Evaluation Section  
Southwest Florida Water Management District**

**September 2009**

**By Jason Patterson and Ron Basso, P.G.**

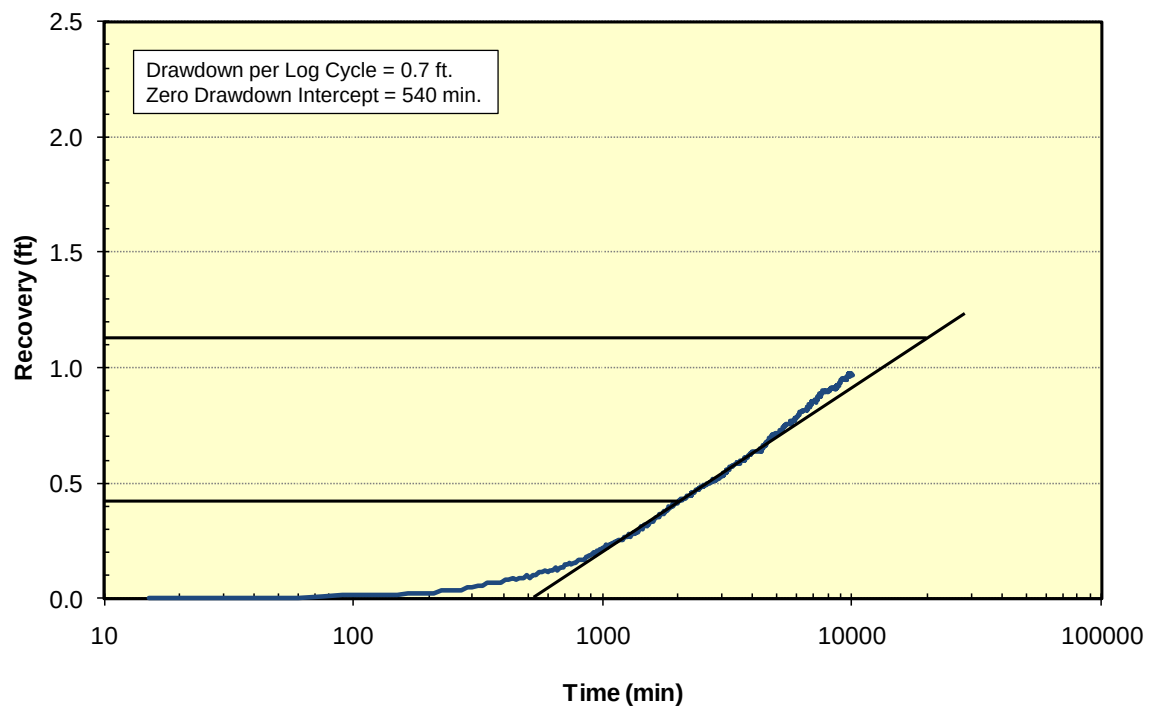
Figure 22. Recovery analysis using the Cooper-Jacob method for the FDOT 1 well.
