# Lake Tarpon Surface Water Improvement and Management (SWIM) Plan Update

## February 2025 FINAL DRAFT

Southwest Florida  
Water Management District  
[WATERMATTERS.ORG](http://WATERMATTERS.ORG) • 1-800-423-1476

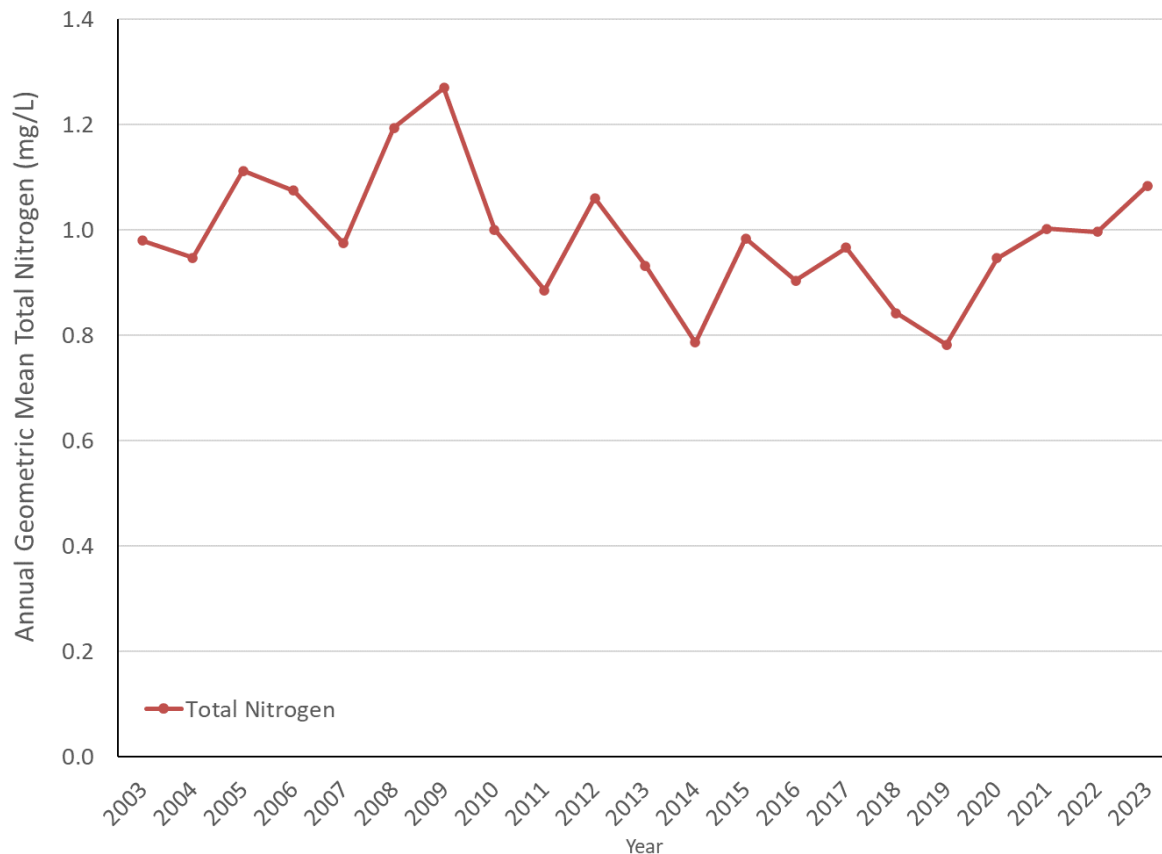
Figure 4 – Time series of TN (mg/L) annual geometric means for the period 2003 to 2023

Statistical analysis did not detect a significant trend

Annual geometric means for total nitrogen concentrations in Lake Tarpon over the period 2003-2023 ranged from approximately 0.8 – 1.27 mg/L (Figure 4). At no time did the TN concentrations exceed the TN NNC of 1.27 mg/L. In 2009, the annual geometric mean equaled the TN NNC (Figure 4). As the data sets met the requirements of parametric statistical analysis of normality and homogeneity of variance, linear regression was used. This analysis did not detect a trend over time ( $p>0.05$ ).
